Final Report

COMPOSITE ACCELERATOR GRID INVESTIGATION FOR CESIUM ELECTRON BOMBARDMENT ION THRUSTER

Contract No.: NAS5-21023

Electro-Optical Systems
Pasadena, California

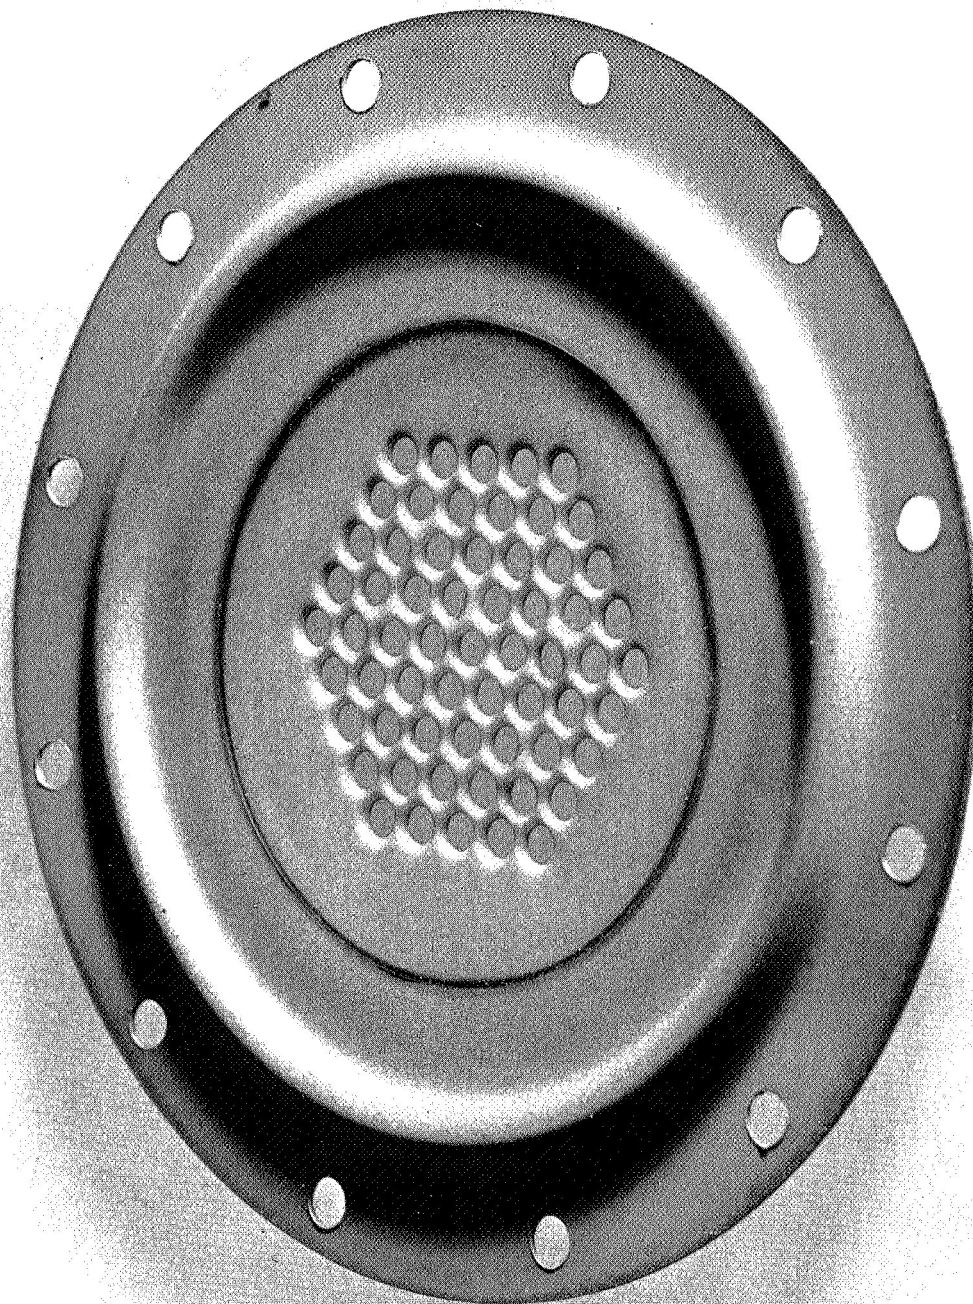
The final version of the moly-manganese metalized alumina electrodes was sent to Goddard Space Flight Center where a coating of 1723 glass was applied to the alumina. This coating improved the optics of the grid, covered the relatively porous alumina with non-porous glass, and provided a medium by which a mounting flange and shadow shield could be attached to the basic composite electrode. Figure 1 shows such a grid fabricated at Goddard Space Flight Center.

Figure 1. 1723 Glass Aluminum and Moly-Manganese Electrode No. 33 (Upstream)

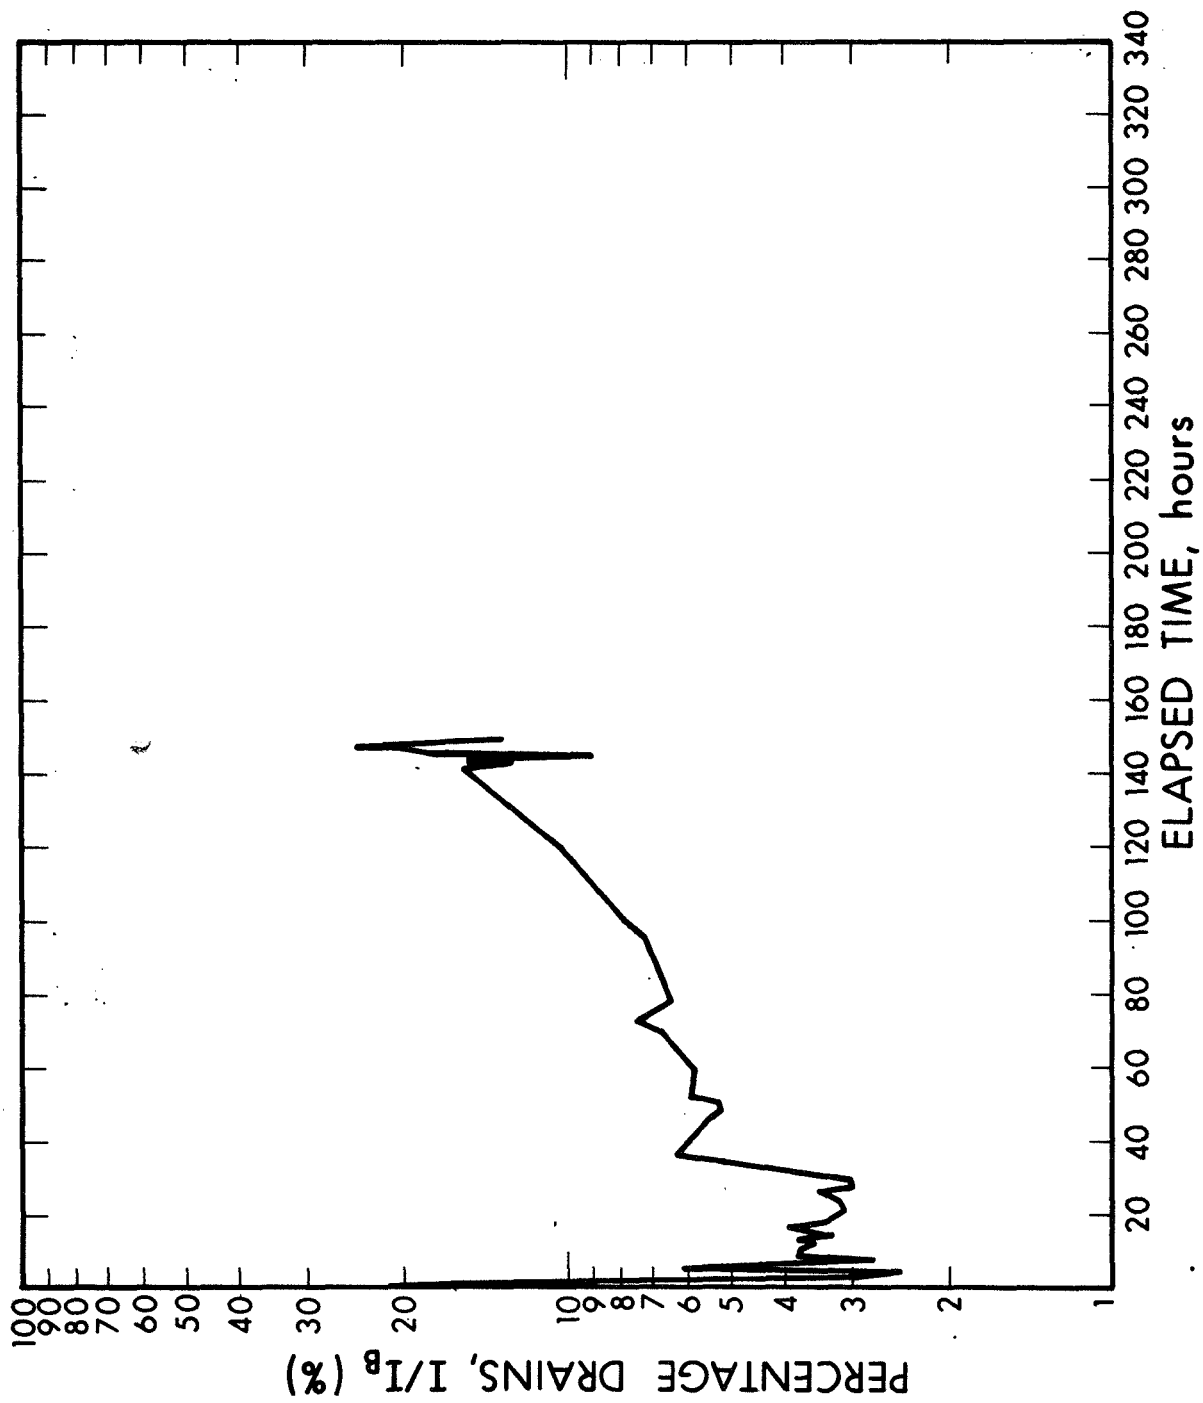
Figure 2. Percentage Drains Histogram for 150 Hour test

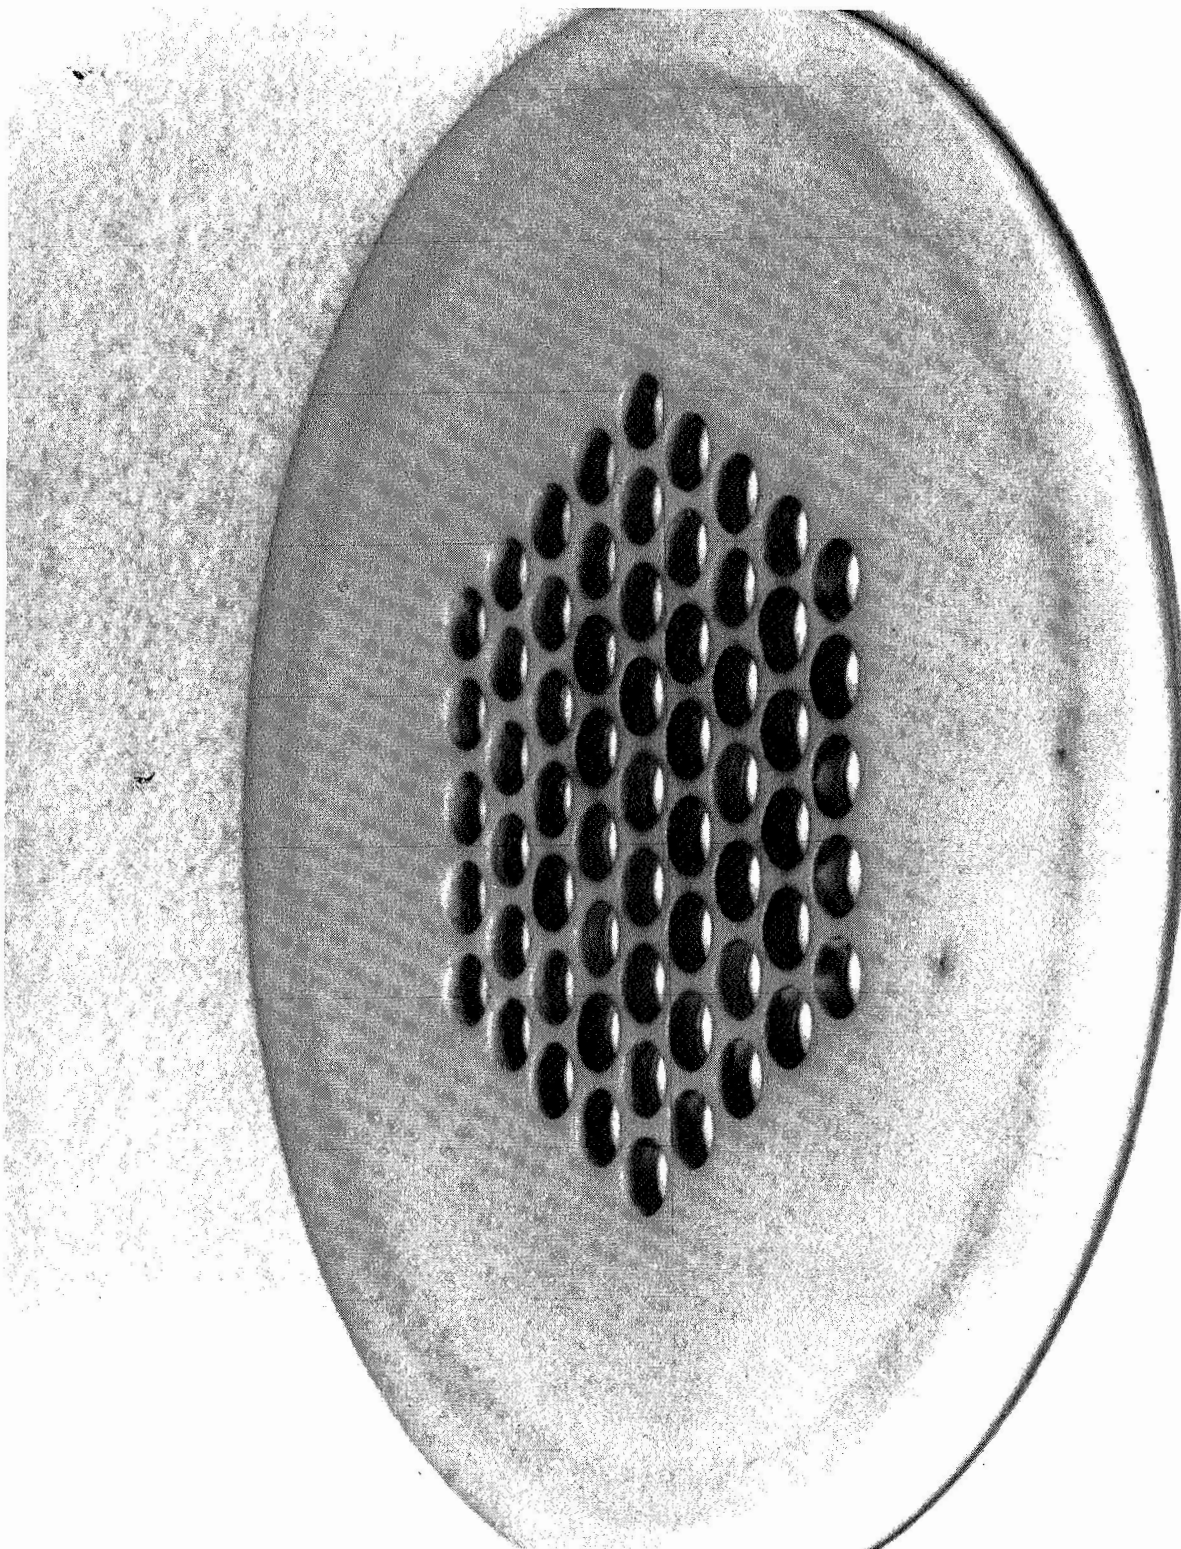
Electrode No. 10 was removed from the thruster and inspected. The insulator in the holes was coated with a conductor which is thought to be a combination of a braze material and niobium. Careful examination revealed that the braze and niobium extended into the aperture so that the accelerator electrode could be directly bombarded by the cesium ion beam. It is believed that this direct impingement caused sputtering and evaporation of the conductor which plated out on the insulator in the apertures. This conductor in the holes could be evaporated or eroded by direct ion beam impingement if the deposition rate is low. Since the deposition rate was high, the conductor in the apertures could cause further defocusing which, in turn, causes an increase in the deposition rate. This eventually leads to surface breakdown and arcing. This theory was supported by a previous materials analysis and by operating composite electrode No. 11.

Many of the holes had the insulators partially coated. A similar coating found on the ground screen tests underwent spectrographic analysis. The major constituents were niobium and aluminum which could have come

Figure 3. Brazed Alumina Electrode No. 10 after 150 Hour Test

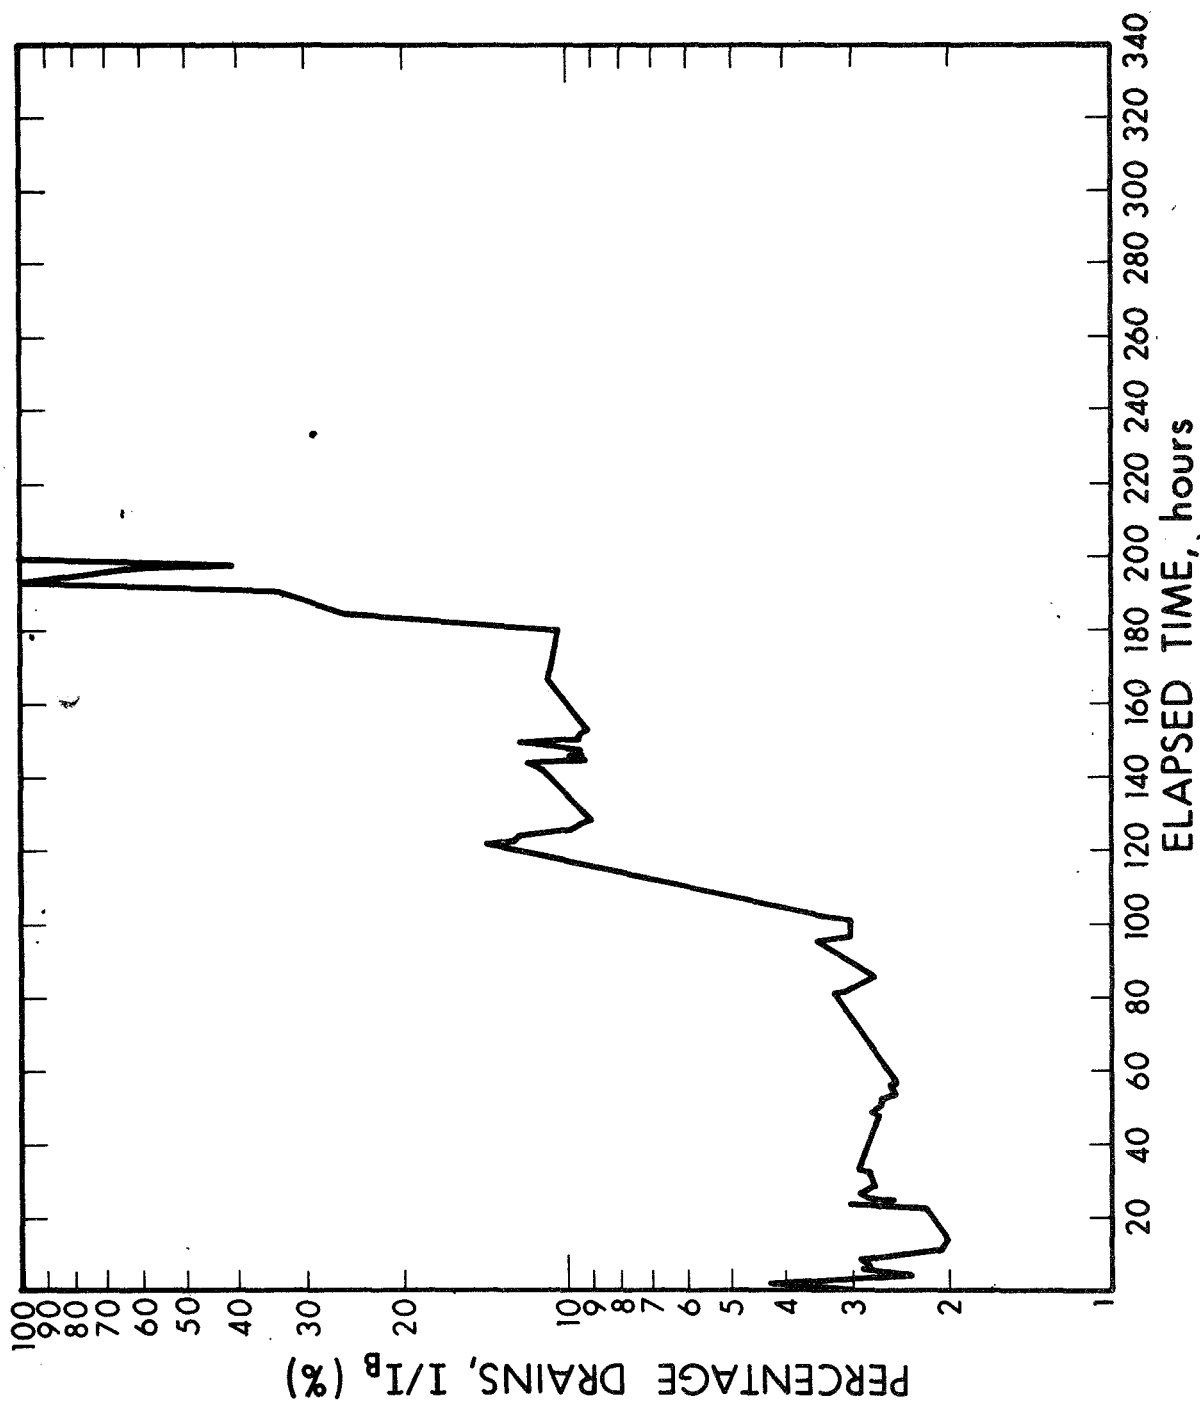
On 4 March 1970, the electrode began its final operational test for 200 hours. Data for typical operation is given in Table VII. The sparking rate was very low throughout the test. The percentage drain currents were below 4 percent for 120 hours, but rose sharply at that time as shown on Figure 4. The mass loss during operation was 0.09 percent. Inspection of the electrode revealed that numerous cracks, visible in Figure 5, were responsible for the high drain currents. The cause of the cracking is not known. There may be a high thermal gradient from the upstream to the downstream side of the electrode which could cause stress. Thermal expansion could cause a force from the electrode mounting clamp. Fastening a thermocouple to the accelerator electrode might also weaken the alumina insulator. Long term

Figure 4. Percentage Drains Histogram for Electrode No. 10 after 200 Hour Test

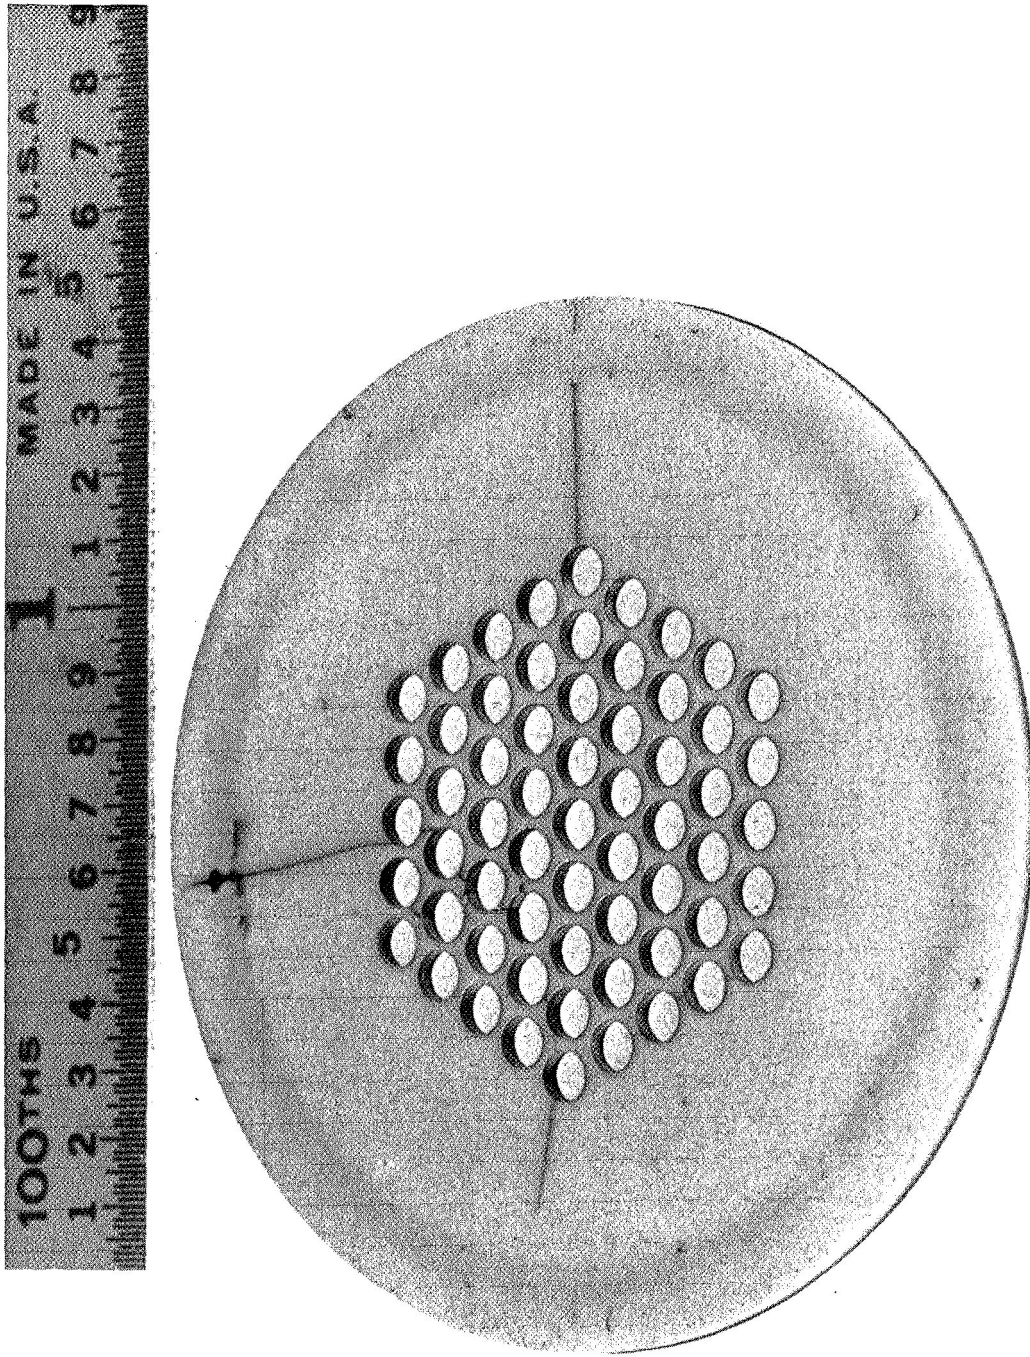
Electrode 10 after 200 hrs

Figure 5. Brazed Alumina Electrode No. 10 after 200 Hour Test

electrical breakdown could cause crack propagation similar to "treeing". Another theory is that there are residual stresses from fabrication which help to propagate cracks with time and other forces. A new mounting technique was employed later in the program which eliminated the first three possibilities. Long term electrical breakdown is unlikely since the electric field is only 16 volts/mil. Residual stresses from fabrication can be eliminated by using different machining techniques and by heat treating.

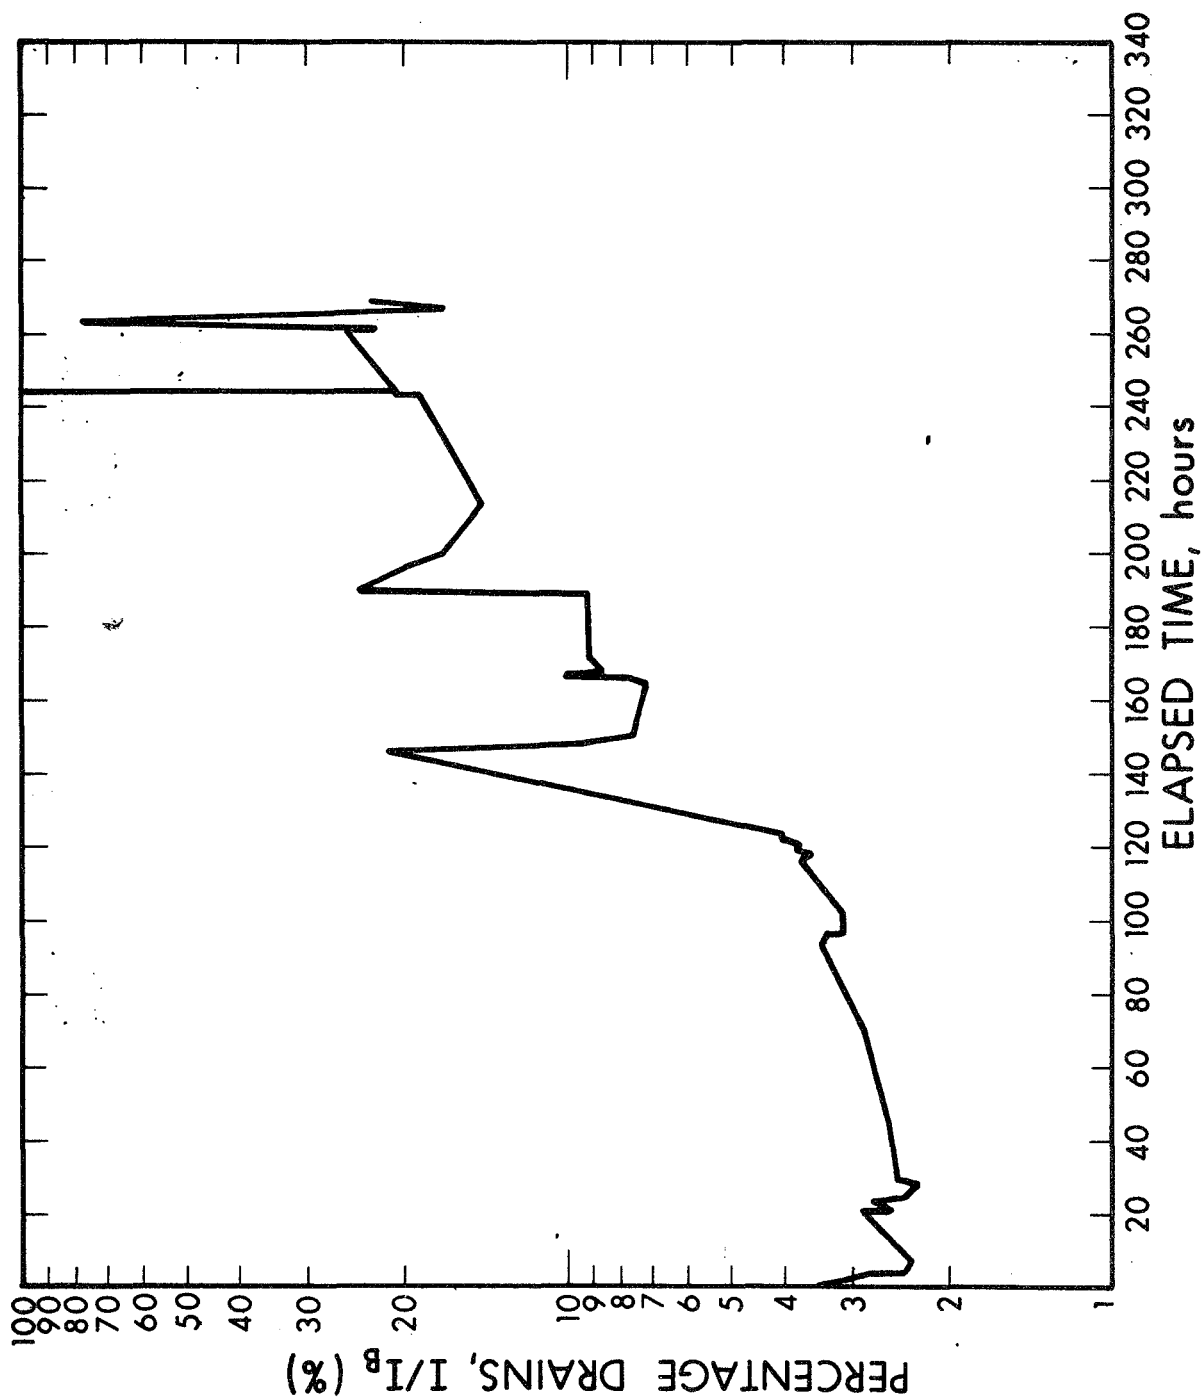
Figure 6. Percentage Drains Histogram for the Thick 7052 Glass Coated Electrode - 268 Hour Test

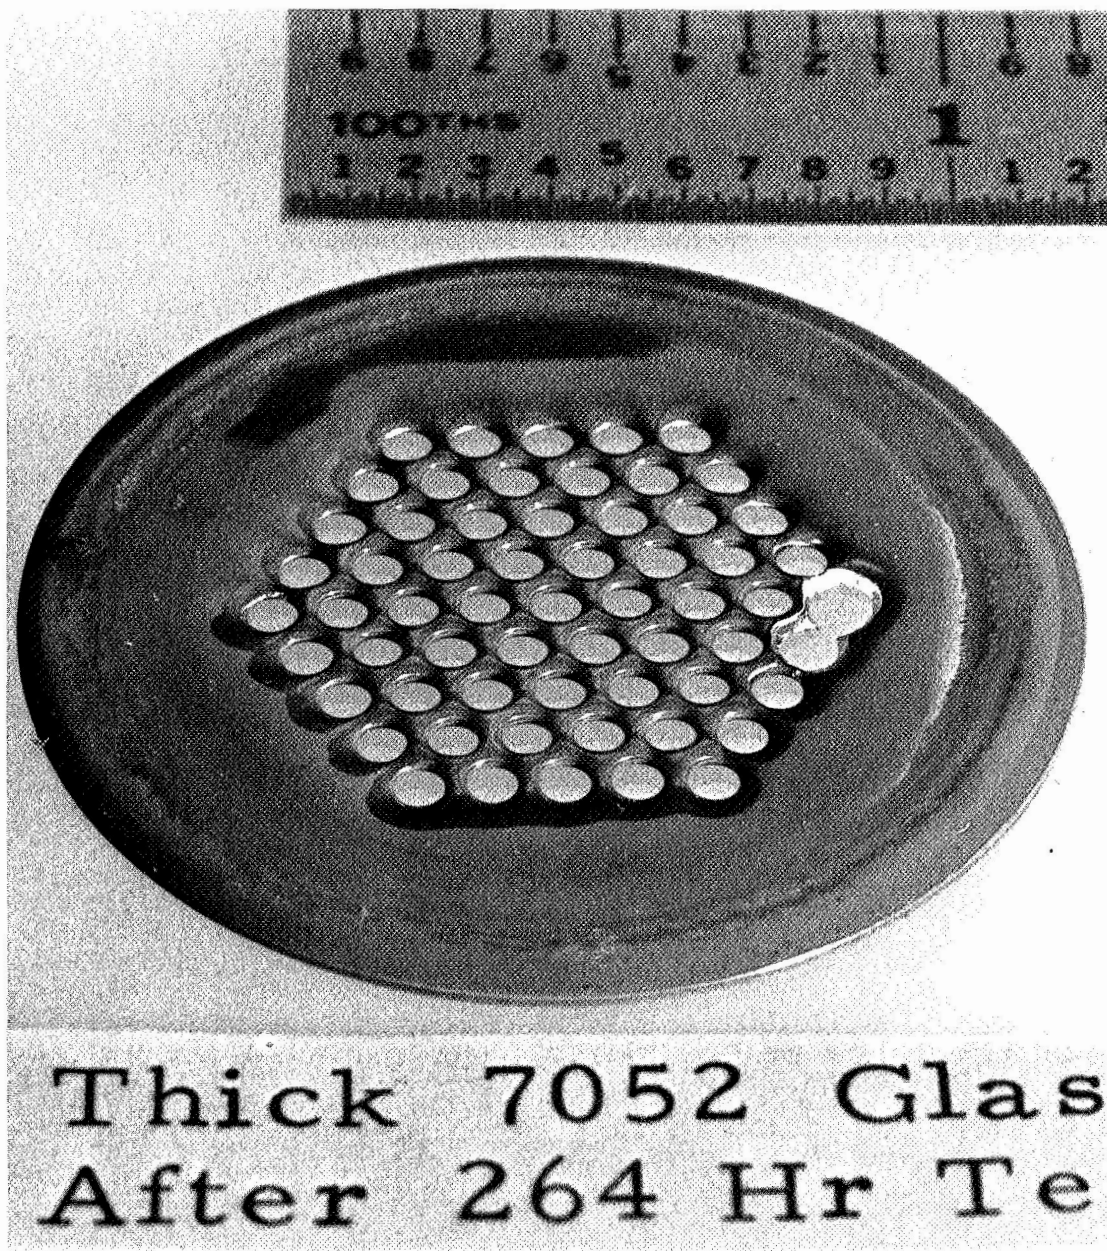
The glass coating was not flat so a soft copper gasket was used between the glass surface and mounting screen. Moderate clamping sealed the joint and no further trouble was experienced. Data points for typical operation are given in Table VIII. Near the end of the test, 10^{-4} torr of argon gas was let into the vacuum chamber and the beam produced a visible glow. The beam was collimated to less than a 15° included angle. The sparking rate was low for most of the test. The percentage drain currents remained below 4 percent for 125 hours as shown in Figure 6. Failure of the electrode was more of a degradation than a catastrophic failure. The test was terminated because a web between two peripheral holes was missing, as shown in Figure 7. The web failure occurred where the glass coating was thinnest. Microscopic examination showed chipping of the glass in the apertures, cracks through the webs, ion beam erosion where cracking occurred, and remelting of

Figure 7. Thick Corning 7052 Glass Coated Electrode after 268 Hour Test

glass over the cracks (possibly in that order). Some of the peripheral webs have brownish spots on them which may be due to the effects of heat and cesium on 7052 glass. All breakdown occurred where the glass coating was thinnest, i.e., on the webs of the peripheral holes. The only exception was at the copper mounting gasket. This would indicate that a thicker glass coating on the peripheral webs and a more alkali resistant glass (1723) should correct the wear out problem.

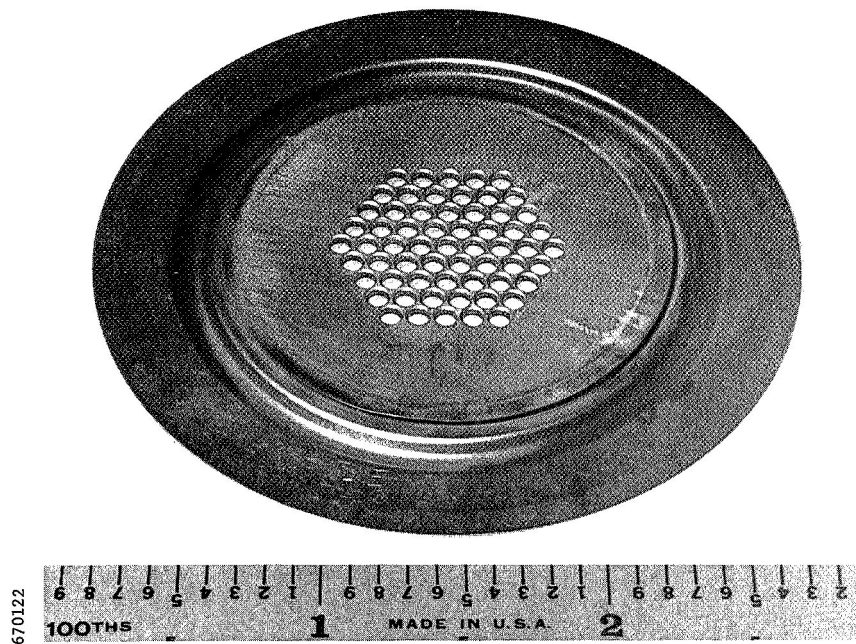
Composite Electrode No. 25 was a 0.005-inch thick niobium electrode brazed to a 0.037-inch thick Lucalox insulator. On the periphery of the upstream insulator a mounting flange was brazed as shown in Figure 9. A convolution in the 0.010-inch thick mounting flange was intended to absorb stresses due to improper mounting and thermal gradients. This mounting configuration meets the requirements of a flight type electrode mount. The relatively small heat dissipating area insured a uniform temperature throughout the composite electrode.

Figure 9. Flanged Lucalox Electrode No. 25 after
104 Hour Test

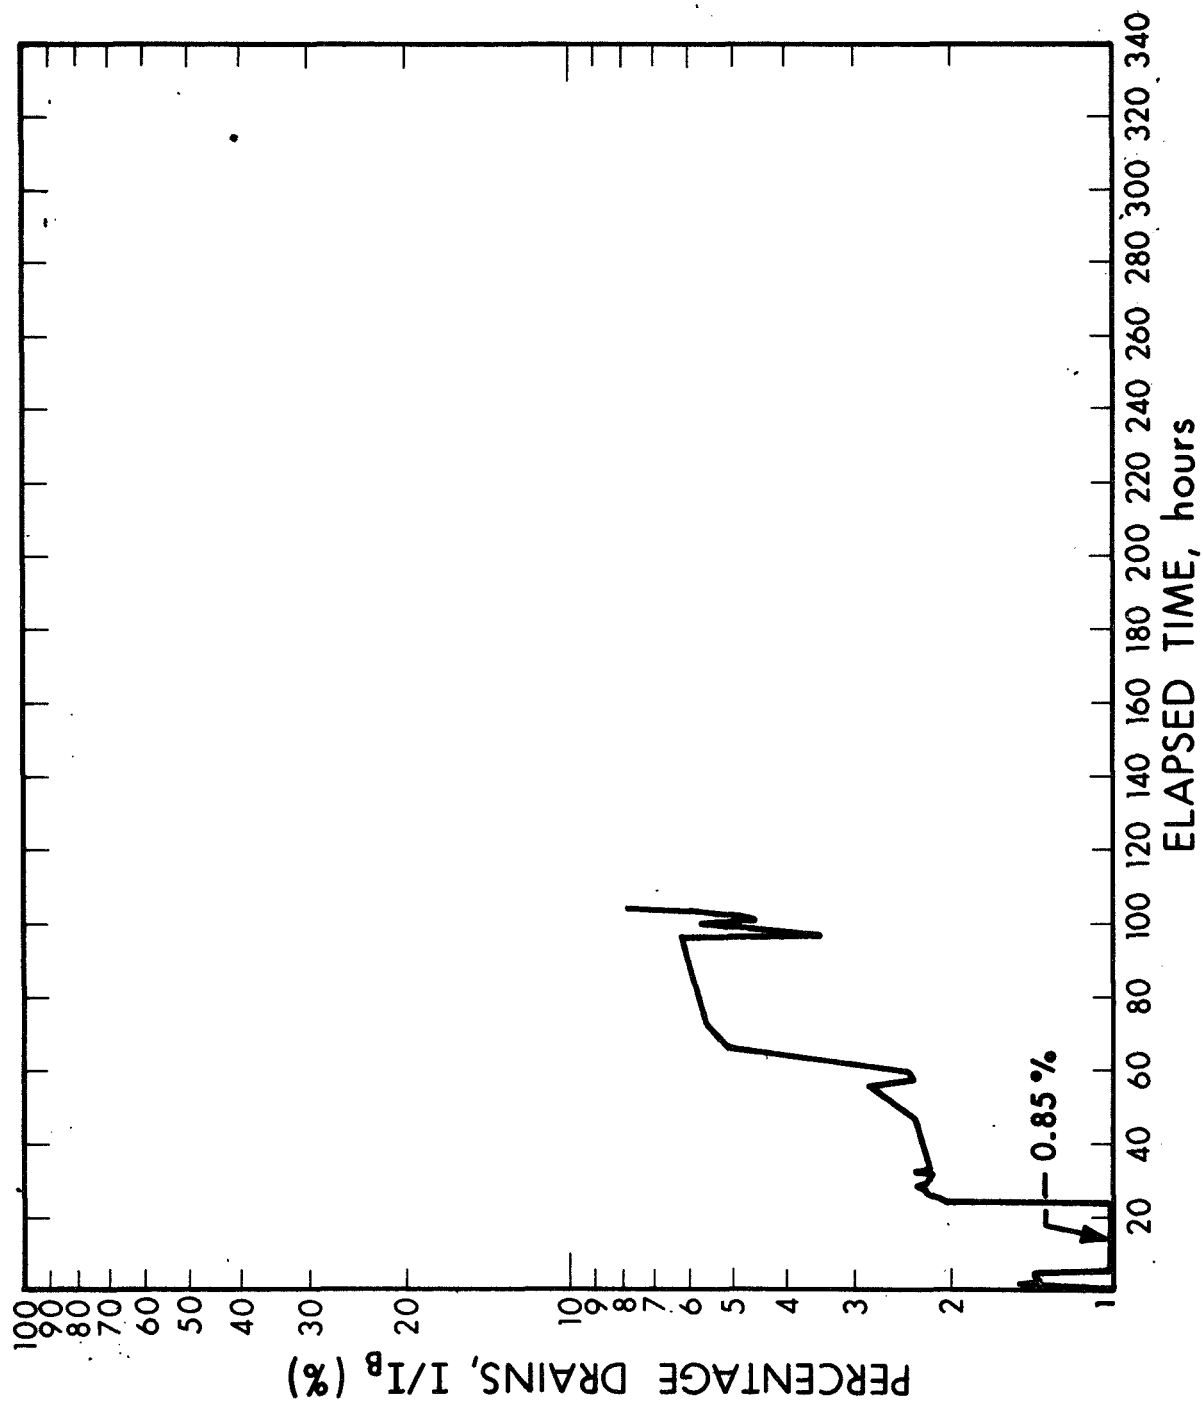
slowly for the remaining 96 hours. The test was terminated with 7.8 percent drain currents as shown in the percentage drains histogram, Figure 10. Typical operational data is given in Table X. The pervance is quite acceptable even though a relatively low beam level was selected for operation. The operational characteristics indicated that some of the braze material was probably left in the holes and was building up a coating in those holes. Removal and inspection proved the theory correct.

Figure 10. Percentage Drains Histogram for the Flanged Lucalox Electrode No. 25 after 104 Hour Test

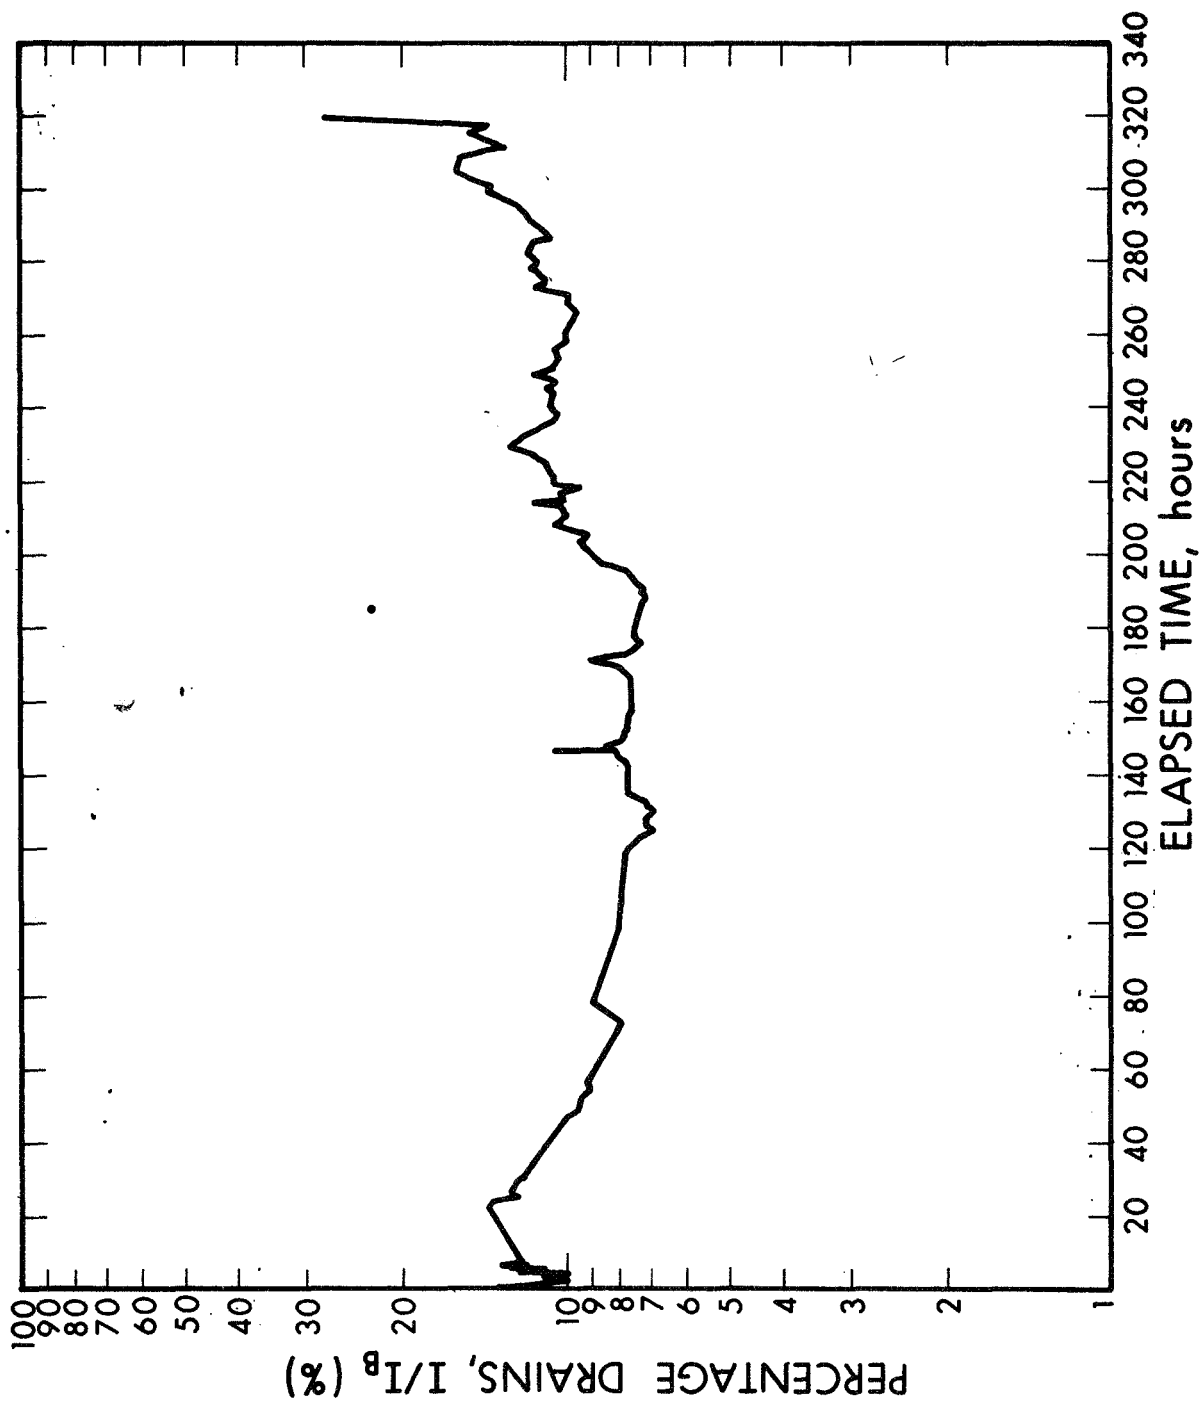
drains were 13.5 percent and dropping. The percentage drain currents continued to drop for the next 190 hours as seen in Figure 11. At 190 hours an upward trend started for the percentage drains which avalanched at 320 hours. Table XI shows that the thruster operational parameters were very consistent throughout the test, except for the control runaway during the first hour. It is not possible to assess what damage, if any, was done to the electrode during the control runaway. Such a runaway can be caused by malfunctioning accelerator electrodes or by several other components in the ion engine system. The possibility of a control runaway was eliminated in subsequent tests by controlling the vaporizer current with the positive high voltage supply current (I_+) rather than the beam current (I_B).

Figure 11. Percentage Drains Histogram for the Flanged 7052 Glass Coated Electrode after 320 Hour Test

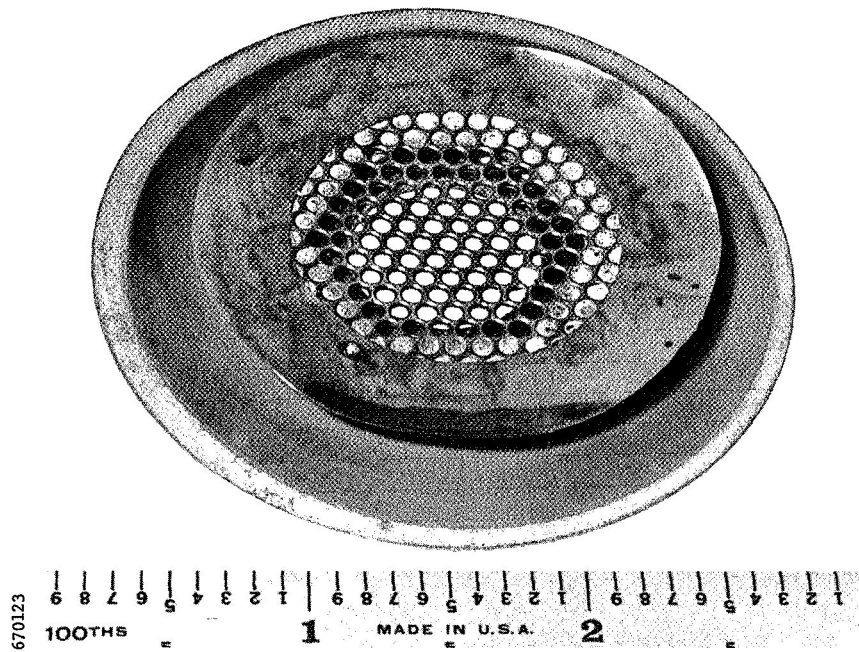
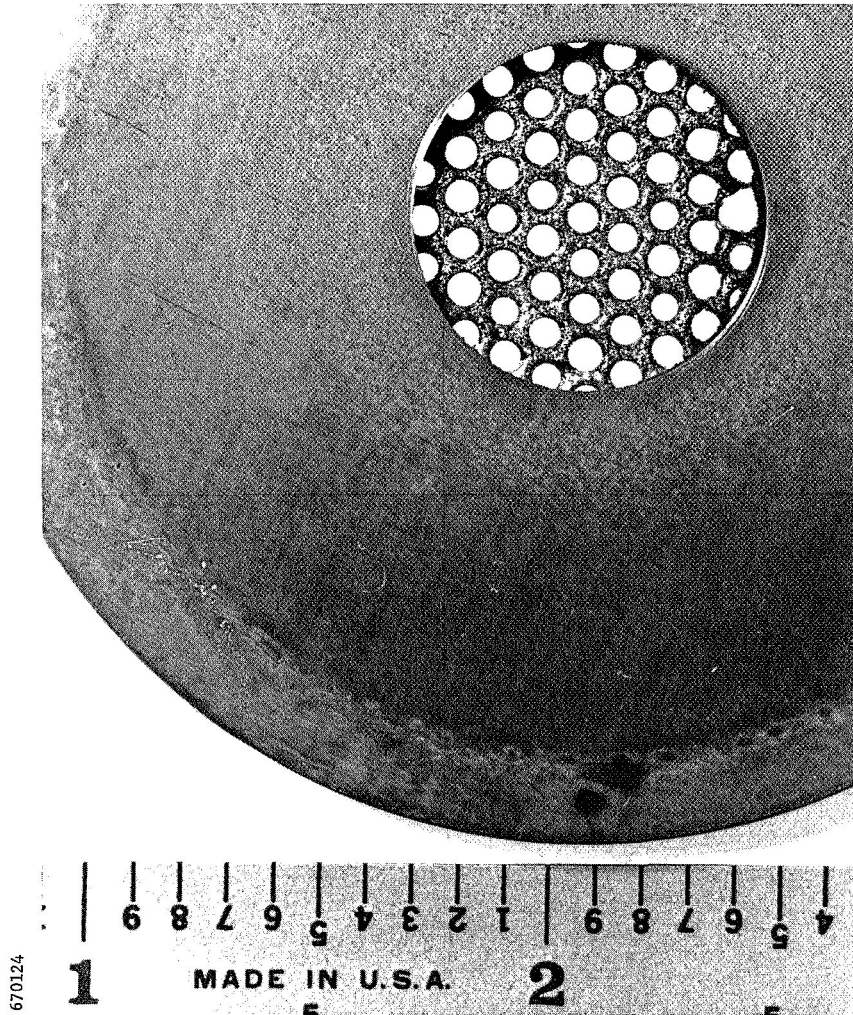
- a. The high drain currents were primarily due to a few eroded holes at the edge of the beam. This is visible in Figures 12 and 13. On the upstream side, one web has no glass and one web has the glass severely eroded.

Figure 12. Flanged 7052 Glass Coated Electrode after
320 Hour Test (Downstream Side)

Figure 13. Flanged 7052 Glass Coated Electrode after 320 Hour Test (Upstream Side)

- b. The inside mounting screen has a deposit near the eroded hole only. The deposit appears to be burnt ceramic and glass.
- c. Several of the bubbles, which were accidentally produced during glass coating, burst during operation. Some holes look burned as if an arc passed through them. The burned bubble holes appeared all over the electrode with the majority near the edge of the glass coating.
- d. The glass around the eroded hole is amber colored.
- e. The glass in the area exposed to the cesium plasma has a gold colored deposit between the 7052 glass and the molybdenum accelerator grid (or between layers of glass). The gold color is not uniform and looks like pure cesium. This is characteristic of alkali attack on glass.
- f. There is a white powdery substance between the mounting flange and the glass coating.
- g. The glass surface was unharmed and clean except where bubbles burst.
